# Inspection Report

## Danica Sample

33977 Stara Lane  
Hendersonville NC

<b>Date:</b> 3/30/2012	<b>Time:</b>	<b>Report ID:</b> 33977staralane
<b>Property:</b> 33977 Stara Lane Hendersonville NC	<b>Customer:</b> Danica Sample	<b>Real Estate Professional:</b> Victor Tate Victor Realty

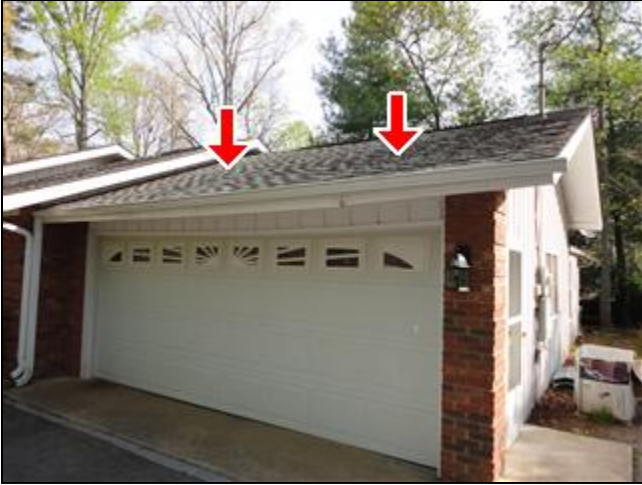
1.0 Item 1(Picture)

🔧 **1.0** (1) Evidence of a leak in the Den below corresponds with the middle skylight roof and flashing area. Repairs are needed. Recommend a qualified contractor inspect further and repair as needed.

🔧 (2) The roof covering was installed improperly above garage. Roof sheathing needs to be replaced in this area. This will involve some shingle replacement. A qualified contractor should inspect and repair as needed.

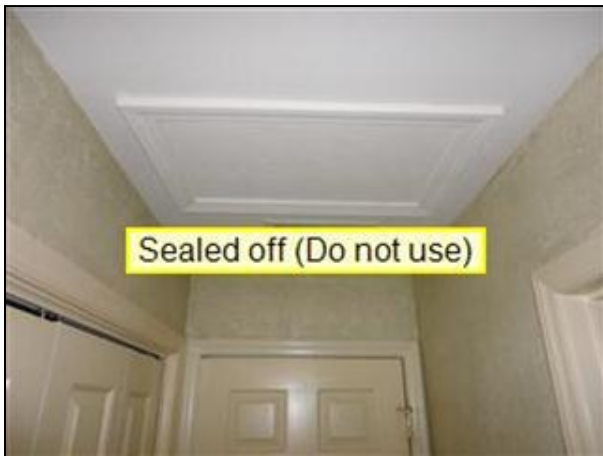
1.5 Item 1(Picture)

**1.5** No longer an attic access. Use the pull down stairs at garage.

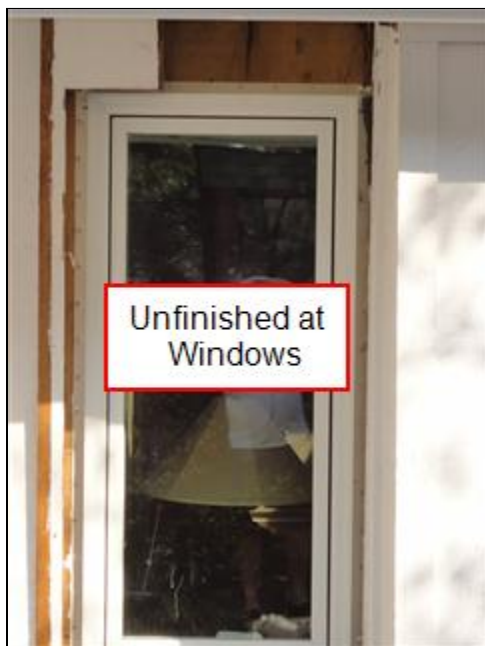
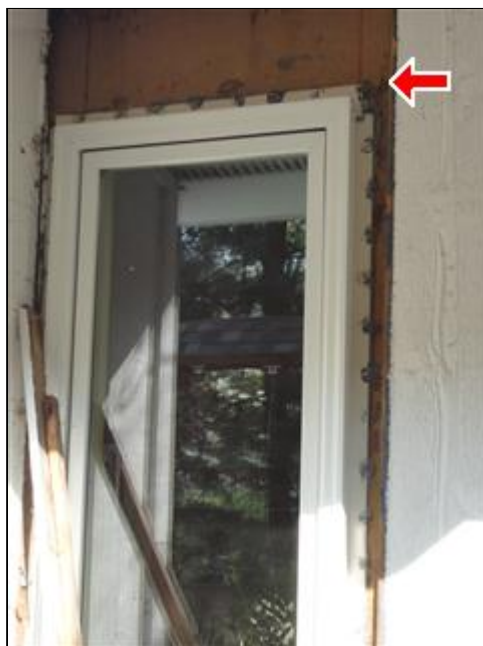
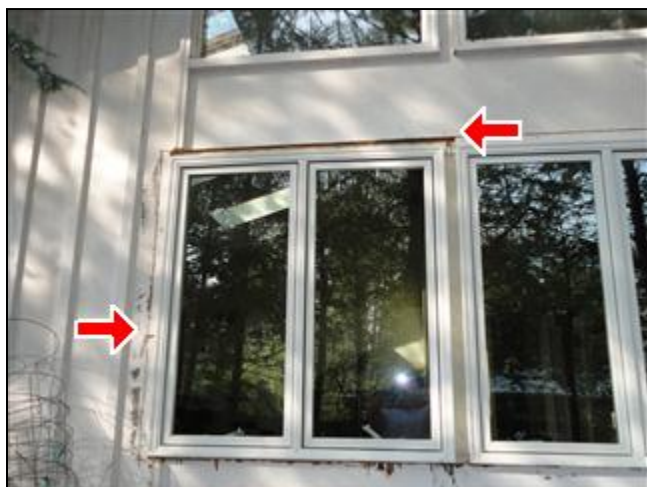
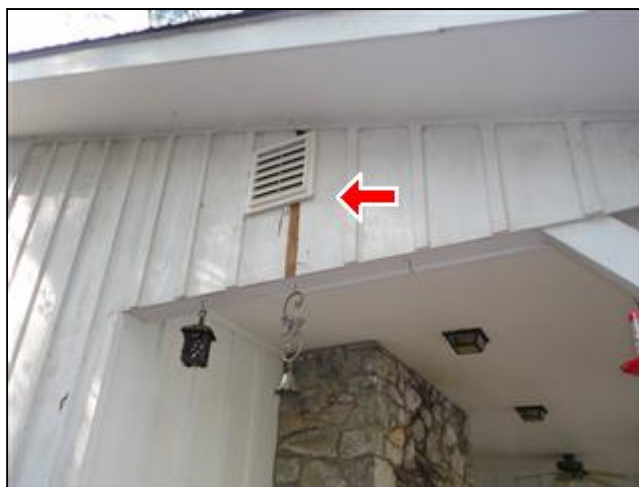
2.0 Item 1(Picture)

🔧 **2.0** The Wood siding at the right side (facing front) and rear of home is missing or incomplete at time of inspection around new premium windows that have recently been installed. I did not inspect the installation of siding at this location. A qualified contractor should inspect and repair as needed. The siding will need prep and paint.

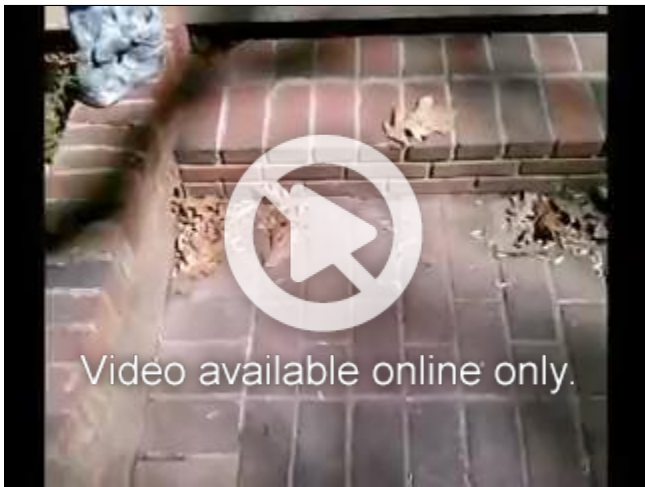
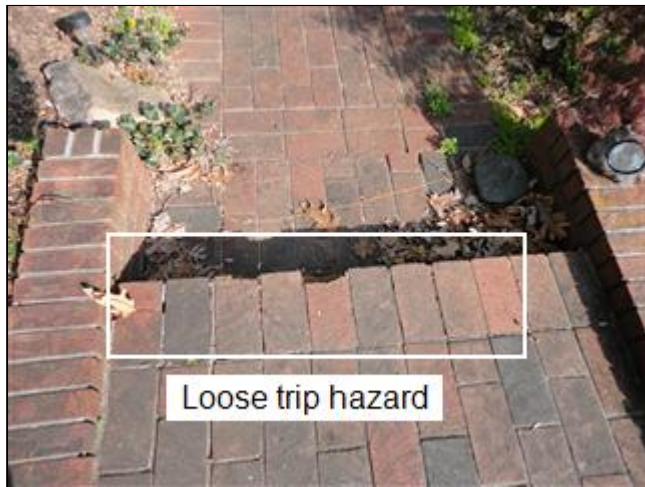
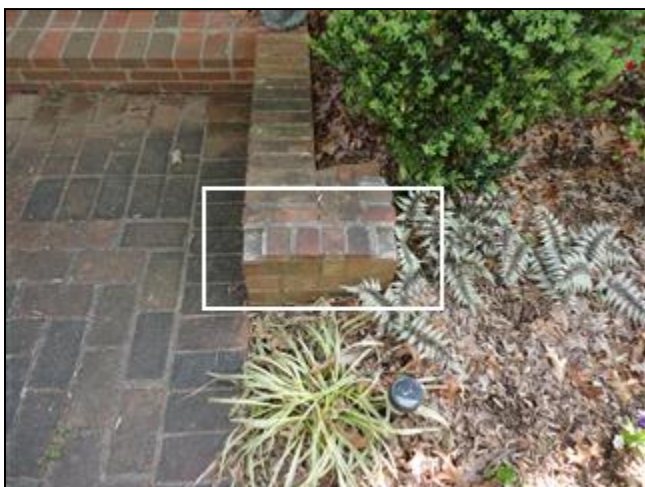
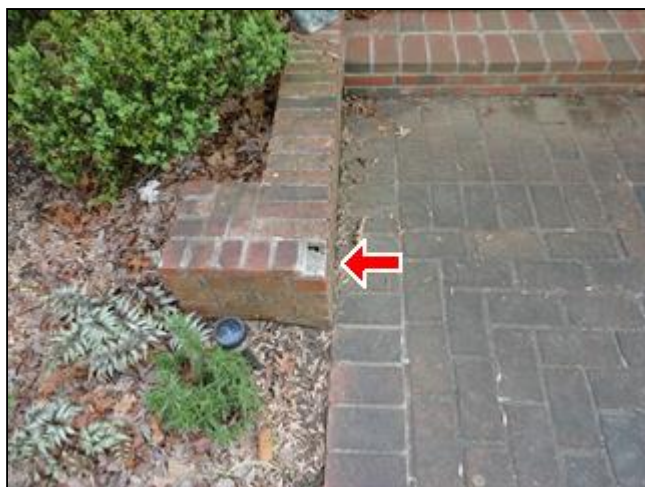
2.4 Item 2(Video) Water signs at front step

🔧 (2) The brick walkway at the front of home are deteriorated in areas. A general replacement is likely. A qualified contractor should inspect and repair as needed.

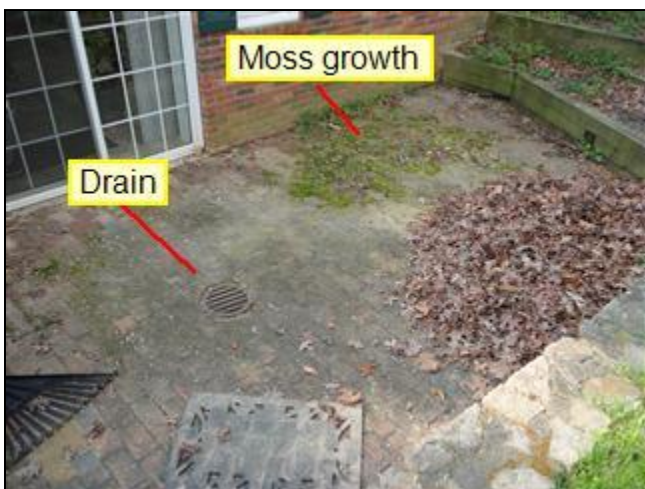
2.4 Item 7(Picture)

🔧 (4) The brick floor on the patio at the left side (facing front) has deteriorated mortar or grout, and is loose and uneven in areas. Water can cause further deterioration if not repaired and sealed properly. A qualified contractor should inspect and repair as needed.

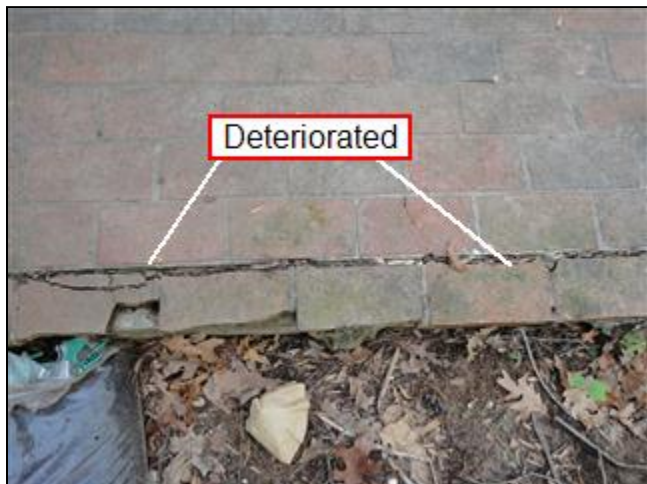
2.4 Item 8(Picture)

🔧 (5) The brick floor on the patio at the rear of home is old and deteriorated. A general replacement is likely. A qualified contractor should inspect and repair as needed.

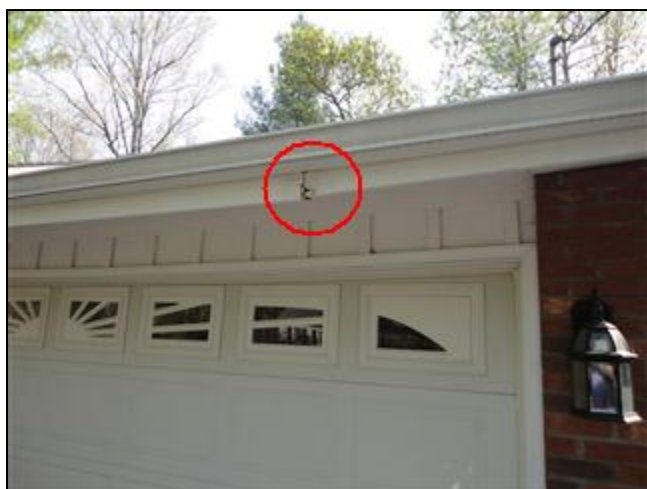
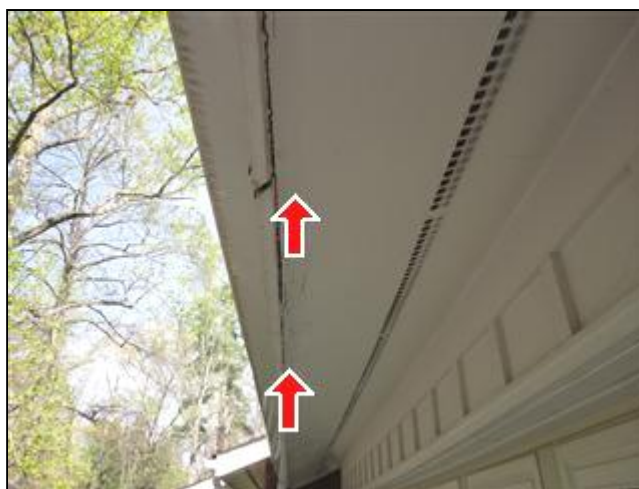
2.5 Item 1(Picture)

🔧 2.5 (1) The wood fascia and soffit panels at eave on the front of home above garage are deteriorated. Repairs are needed to roof covering as well. A qualified contractor should inspect and repair as needed.

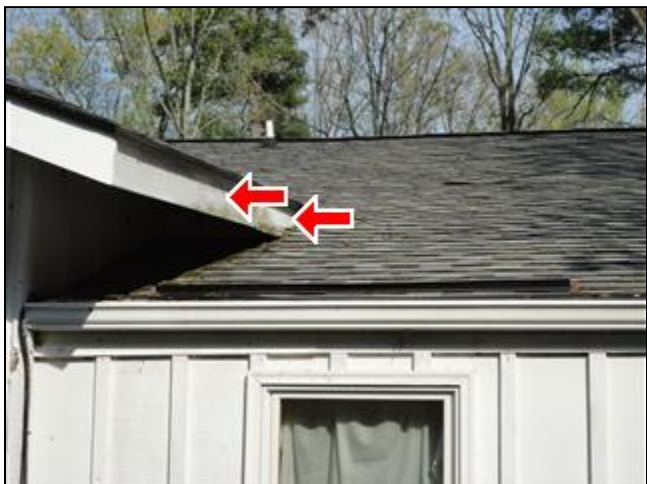
2.5 Item 3(Picture)

🔧 (2) The wood fascia at eave on the right side (facing front) is deteriorated. This is a small repair. A qualified contractor should inspect and repair as needed.

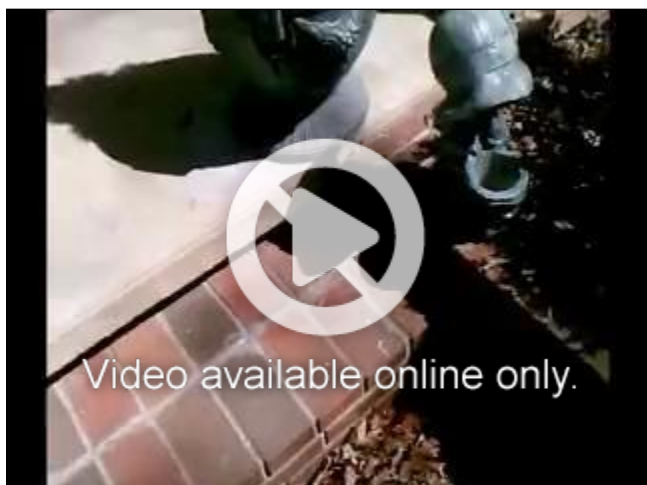
2.8 Item 1(Video)

**2.8** Possible bees nest forming at right corner of front steps (see video)

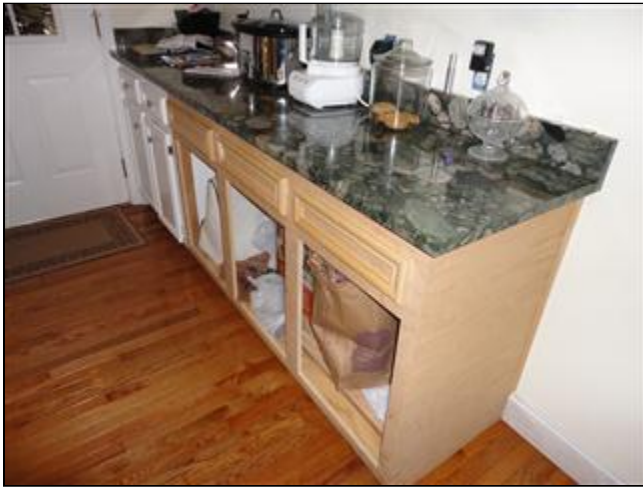
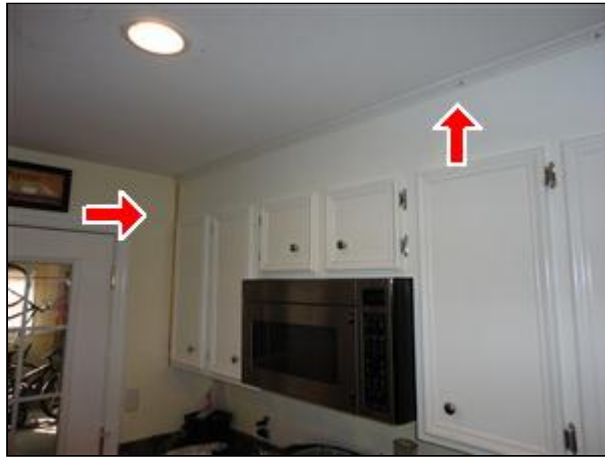
4.5 Item 1(Picture)

🔧 4.5 Base Cabinetry and trim at wall cabinet are unfinished at kitchen.

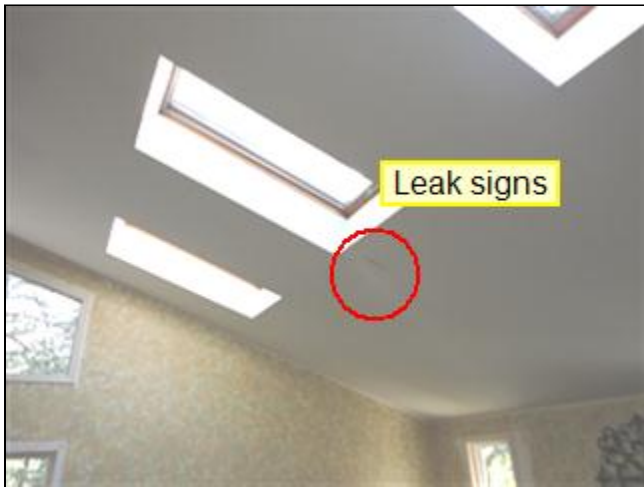
5.0 Item 1(Picture)

🔧 **5.0** (1) The Sheetrock on the ceiling reveals a water stain indicating a leak did or still exists at the Den. Repairs are needed. A qualified contractor should inspect and repair as needed (See Roof Coverings).

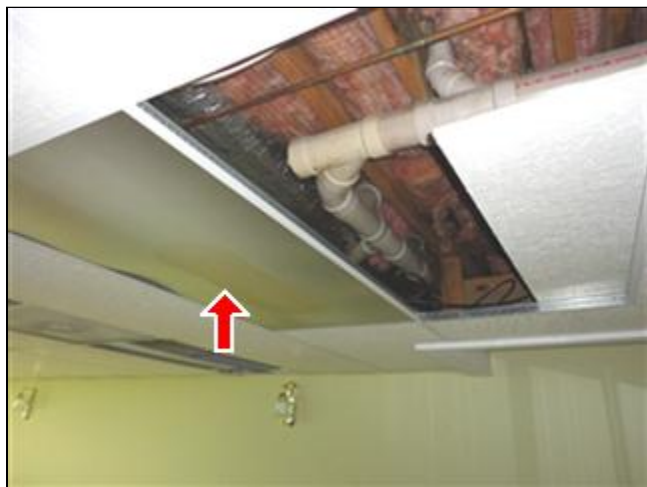
5.0 Item 2(Picture)

🔧 (2) Water stain on ceiling panel lower level indicates plumbing leak.

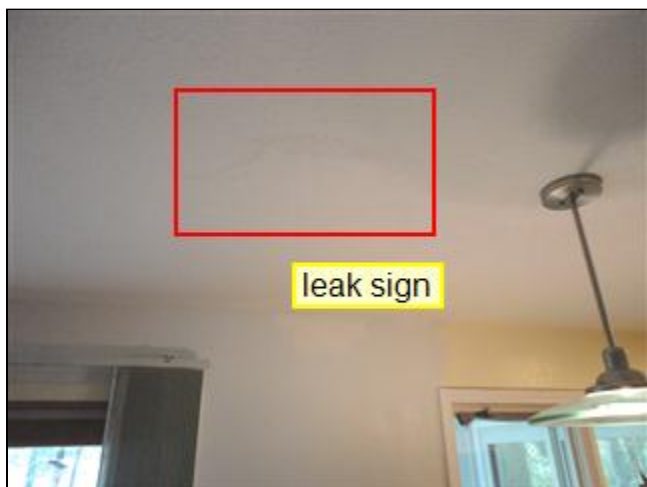
5.0 Item 3(Picture)

🔧 (3) The Drywall on the ceiling reveals a water stain indicating a leak did or still exists at the Dining Room. Repairs are needed. A qualified contractor should inspect and repair as needed.

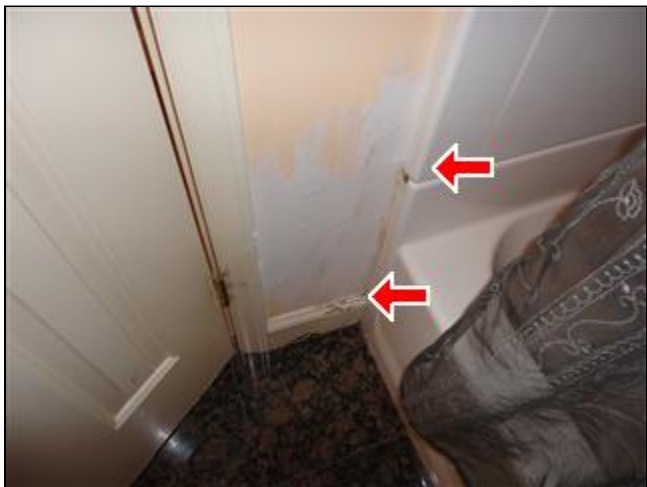
5.1 Item 1(Picture)

🔧 (2) The Wall at the bathtub is deteriorated and needs repair or replacement. The wall board and framing may need repair (not visible). I recommend repair or replace using a qualified contractor.

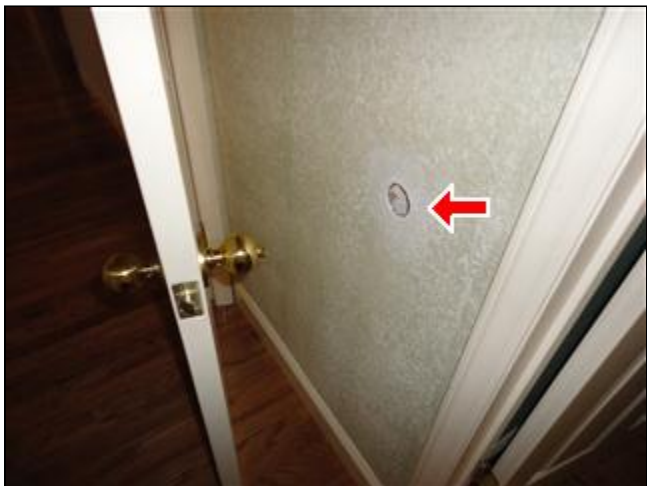
5.1 Item 2(Picture)

🔧 (3) The sheetrock on the wall is dented or damaged from door knob at the hallway. While this damage is cosmetic, it needs to be repaired. A qualified contractor should inspect and repair as needed.

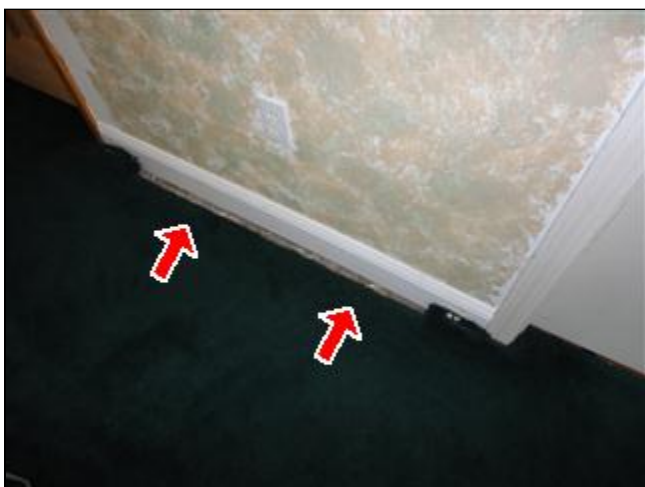
5.2 Item 1(Picture)

🔧 5.2 Carpet is loose or cut short from where electric baseboard use to be in areas around the perimeter of the Den.

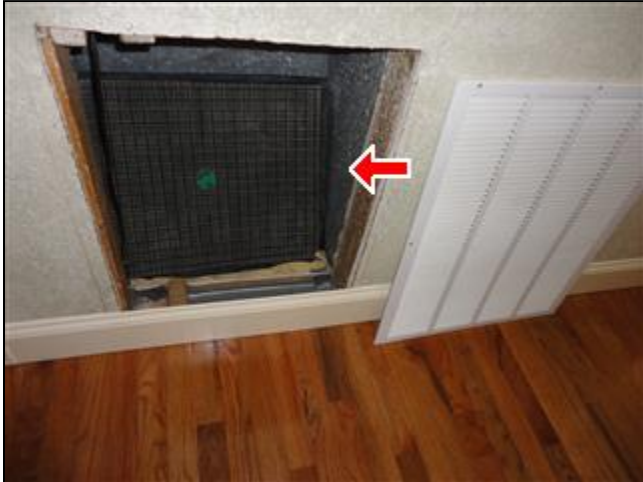
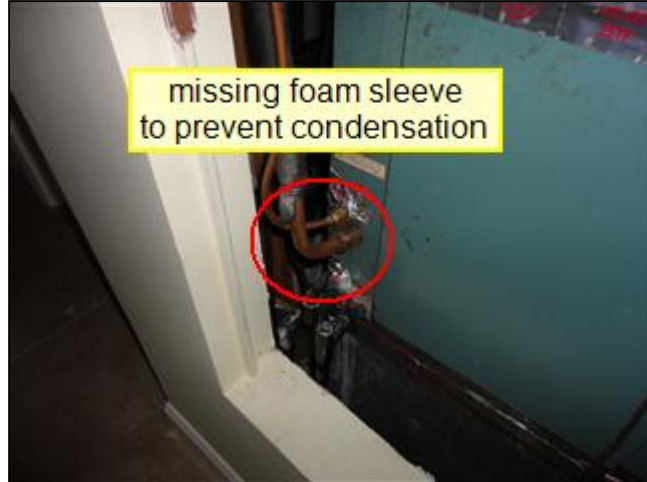
10.3 Item 1(Picture)

**10.3** The washable filter is dirty. The filter needs to be cleaned. Recommend foil taping the filter for a better seal. See Video. Foam sleeve missing at suction line creates condensation and drips water.

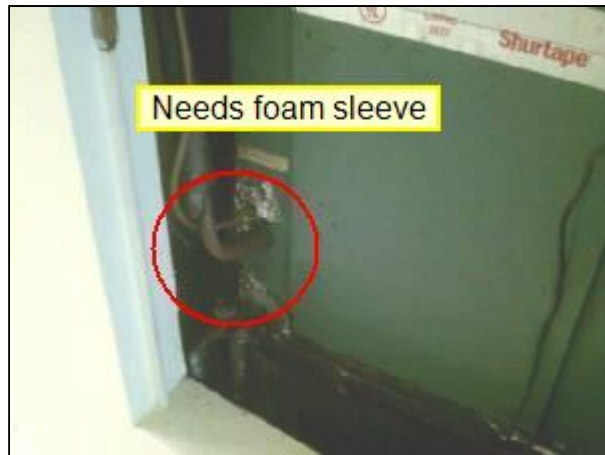
10.8 Item 1(Video)

**10.8** Air handler and heat pump is old but appears to be working properly. Foam sleeve on suction line is not covering copper line and condensation can drip.
